Selma Al Radi Roberto Nardi Chiara Zizola

AMIRIYA MADRASA

THE CONSERVATION OF THE MURAL PAINTINGS

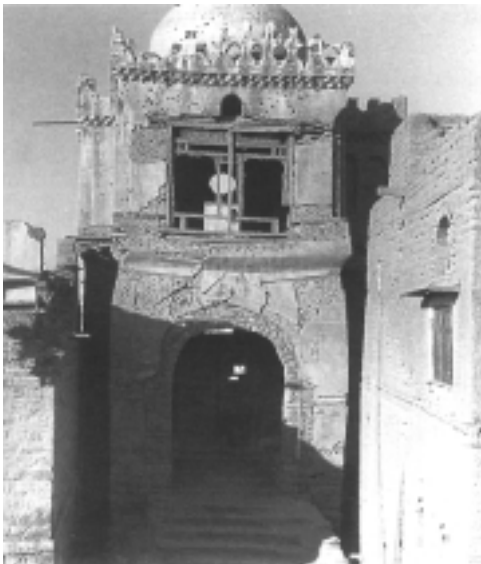
7. The project's real nightmare was the monumental eastern portal

The project's real nightmare was the monumental eastern portal; that it still stood was a minor miracle (Fig. 7). A major cause for the disintegration of the *qudad* was the tribal habit of firing bullets at the walls. Thousands of bullet holes had punctured the plaster, pock marking the facades and leaving gaping holes through which rainwater could enter. Even mortar shell craters from the many tribal feuds and civil war battles (1961-68) that raged around the town, and in the surrounding heights, had left their mark¹⁰. These holes contributed to the disintegration of the 'Amiriya; they broke the protective *qudad* skin and allowed percolation, leaking and erosion to damage the walls.

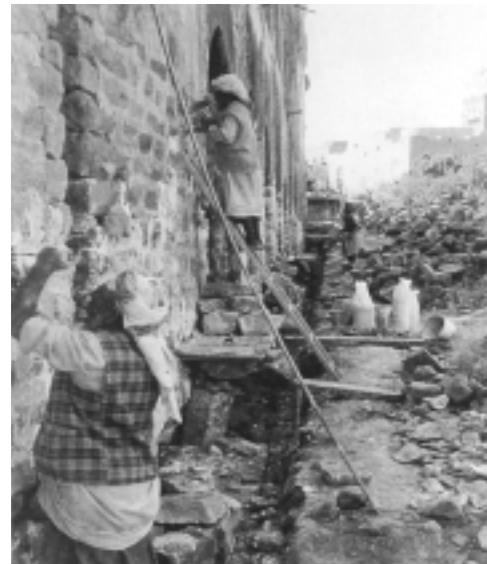
8. Restoration work began from the outside in.

Restoration work began from the outside in. The first priority was the consolidation of the foundations of the 'Amiriya. This was followed by the conservation of the walls, the exterior facades, the interior walls and rooms, and finally the roof and external decorations.

We were able to check the condition of the foundations by digging a trench alongside the facades and exposing them, and repair them where necessary (Fig. 8). Once that was completed, the trench was filled in and packed with dry stones. Diluted gypsum, *sabba*, was poured into the cracks between the stones so that it bonded to the building. This type of low, bench-like retaining wall is called a *bughla* in Yemen, literally a she-mule, inferring that it carries the load. We built *bughlas* along the west, north, and east sides of the 'Amiriya. The top course of the *bughla* was made level with the arched doorways, acting like a step in front of the building. It became an extremely popular gathering place with the local tribesmen, who used to deposit their women-folk and shopping bundles there while they went into Rada' on business.

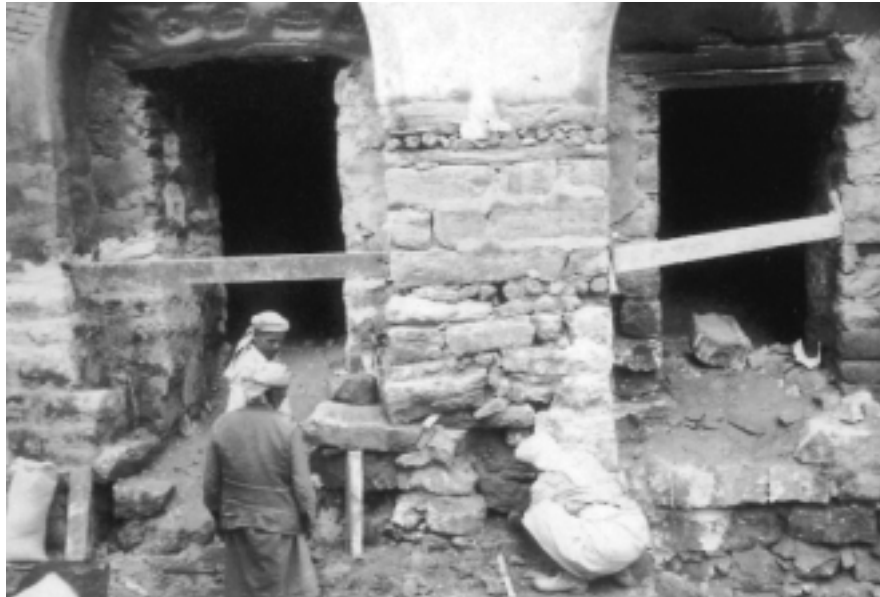
9. Rebuilding the lower sections of the arcades and piers was the first thing to be tackled.

The restoration of the west side was relatively easy. The east facade was another matter. Rebuilding the lower sections of the arcades and piers was the first thing that had to be tackled. Each stone had to be checked and the loose and eroded ones taken out. The exposed gaps were propped up with stakes, and the overhang was kept in place by wooden wedges (Fig. 9).

The section was then cleaned, the stones replaced in proper alignment, and a thick gypsum mortar was used to strengthen the bond. If the original stones were in good condition they were reused; if not, they were replaced from our stock of stones, collected from the dismantled house and shops. This process was repeated for each pier.

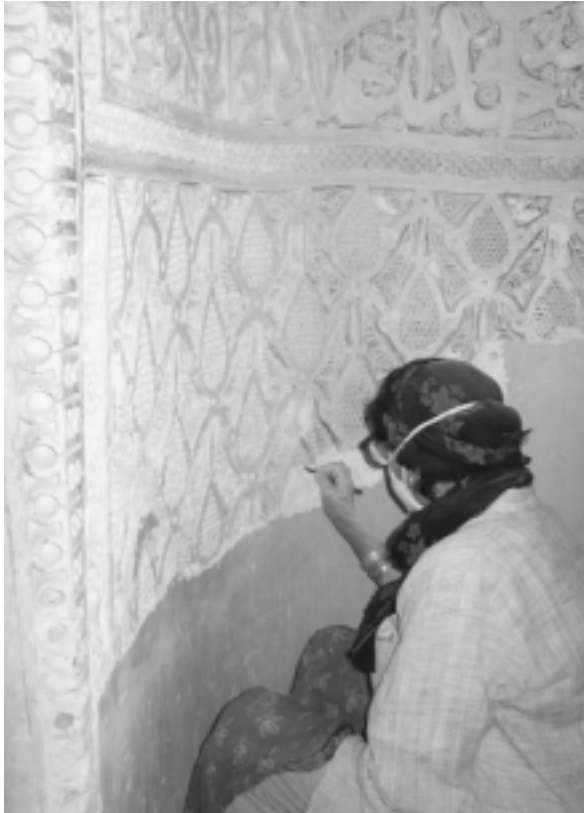
13-14. It has taken nearly fifteen years of work to completely remove the layers of whitewash and uncover the carved stucco in the prayer hall

It has taken nearly fifteen years of work (by the author and an apprentice) to completely remove the layers of whitewash and uncover the carved stucco in the prayer hall. This task has now been completed and the designs and patterns can now be seen clearly in all their splendor (Fig. 13-16).

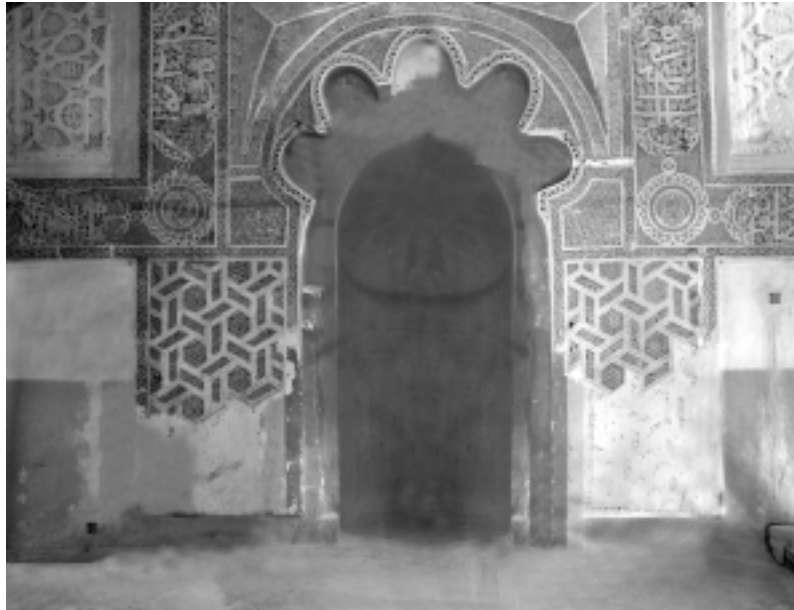
15. Lurid colors, green, red and blue were used in thick layers to cover the mihrab decorations

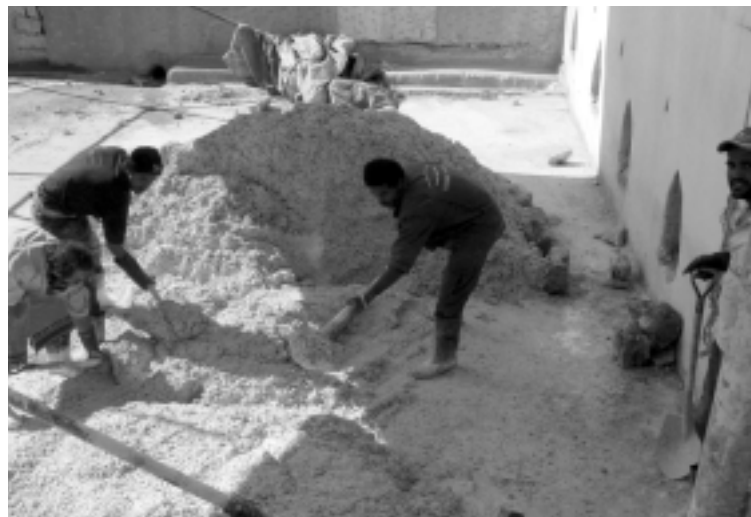
17. Pebbles and sand are mixed together in a ratio of two parts of aggregate to one part of lime. They are then blended together with water and pounded with a long shovel or wooden paddle.

2. While the lime is being slaked, the surface to be covered with *qudad* has to be prepared. A roof surface takes time to prepare. The temporary mud-plaster or *mirja*, which has protected the roofing materials (beams, twigs, etc. until they have settled, has to be partially removed, and small stones, or *midhar*, embedded in it. Just before the roof (or wall surface) is ready to receive the *qudad*, it has to be doused with water and dampened. If it is a wall facade, then the surface has to be cleaned free of any dust, and the bricks and/or stones washed down and articulated so that the first layer of *qudad* can adhere, and penetrate into the crevices.

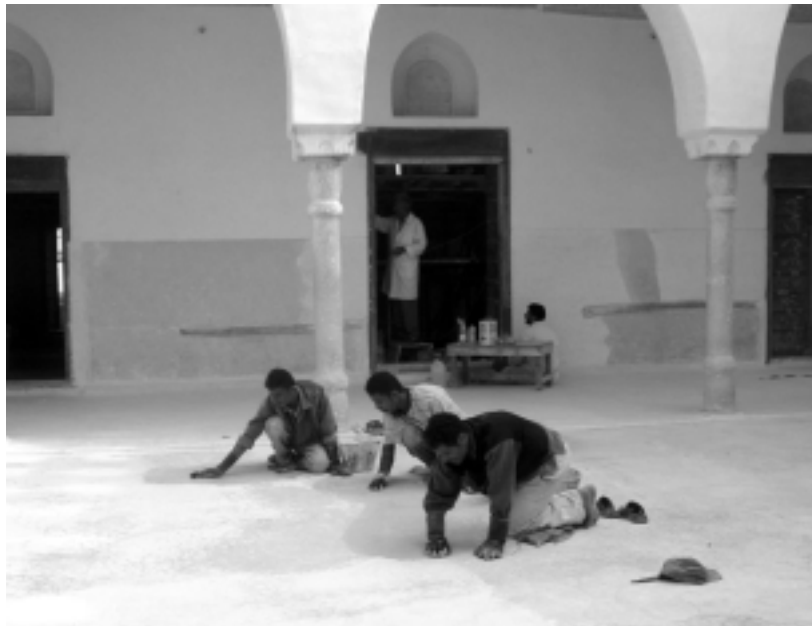
18. Polishing, or rather burnishing the surface of qudad with a smooth, rounded, riverine pebble produces an almost marble-like quality material

or rather burnishing, the surface with a smooth, rounded, riverine pebble until it attains a hard, almost marble-like quality. Burnishing requires the use of the full weight of the hand, pressing the pebble down and moving it in either a circular or an up and down rhythmic fashion (Fig. 18). Again the *qudad* has to be kept moist at all times with a watery lime-wash; this can be sprinkled on the *qudad* with a small broom. Burnishing is the most important step of the *qudad* work. The work is painstakingly monotonous but perseverance is essential. Morning and evening shifts have to be organized lest hairline cracks appear on the surface. Each evening when work stops care must be taken to wet the *qudad* so that it stays moist until the next morning's shift - this is essential for the first four or five days. After that, the *qudad* can be polished twice a day. This twice-daily polishing must be kept up for a period of three or four days, at least. Burnishing then decreases to once a day, then once every two days. This frequency has to be maintained for at least two to three weeks. The physical appearance of the *qudad* must be scrutinized carefully every day for cracks. If even the faintest of hairline cracks appears, polishing has to be prolonged. In fact, polishing and burnishing can stop only when no cracks can be seen, and when the surface develops the appearance and sheen of marble. The time for the burnishing phase must be judged by the *usta* on site; it cannot take less than a month, and six weeks is a more likely estimate.

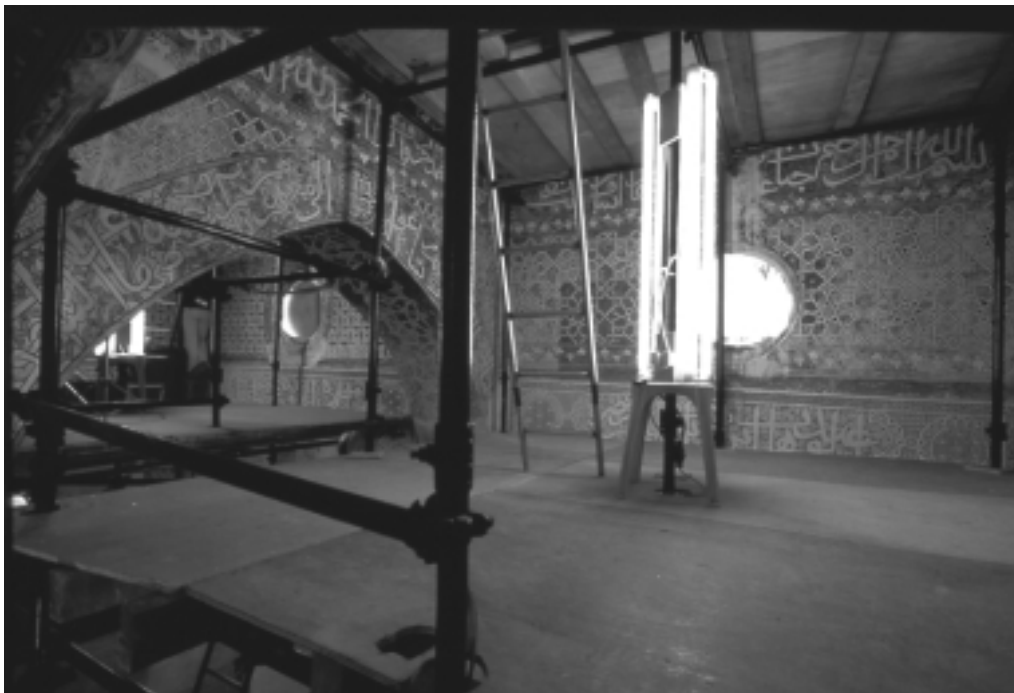
20 The scaffolding was equipped with an autonomous system for power and lighting.

The scaffolding was equipped with an autonomous system for power and lighting and also had portable exhaust fans for use only when necessary. Water and waste disposal were not installed inside the hall for safety reasons. The type of lighting used in the worksite is a major consideration: we installed fluorescent tubes with clear light for restoration. These were low consumption (36 watt), mounted singly or in pairs on simple, quick supports with a plastic protection. They could also be rotated inside the space (Fig. 20).

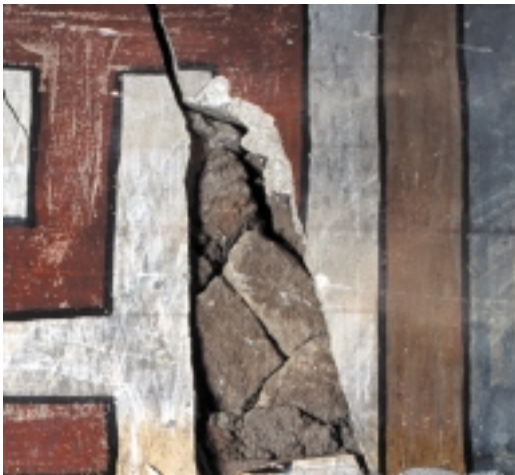
27. Dome 4. Stratigraphy of the support with the brick structure evident.

The wall support is composed of baked mud brick, laid with clay mixed with vegetable fibers (Fig. 27-28). Small wooden beams are inserted in the masonry at regular intervals, horizontally and transversally inside the structure to form a grid. This makes the structure more elastic and permits a proper distribution of the load and partial absorption of vibrations during earthquakes². These wooden inserts are not visible in the vertical walls because they are covered with plaster, but can be seen in the domes, where they protrude at least 5 cm from the painted plaster (Fig. 29).

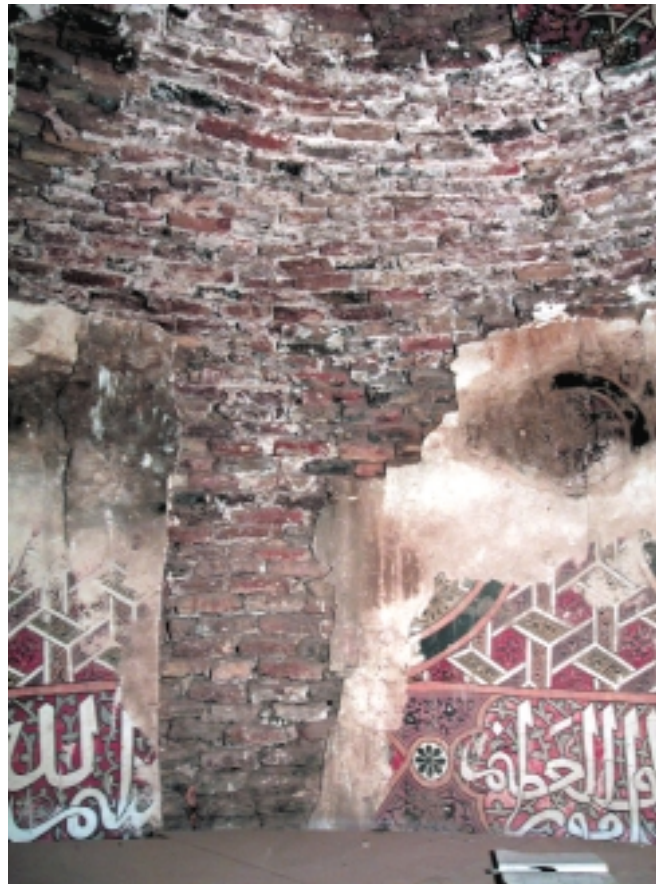
28. Dome 5. Detail of the brick structure in an area of missing plaster.

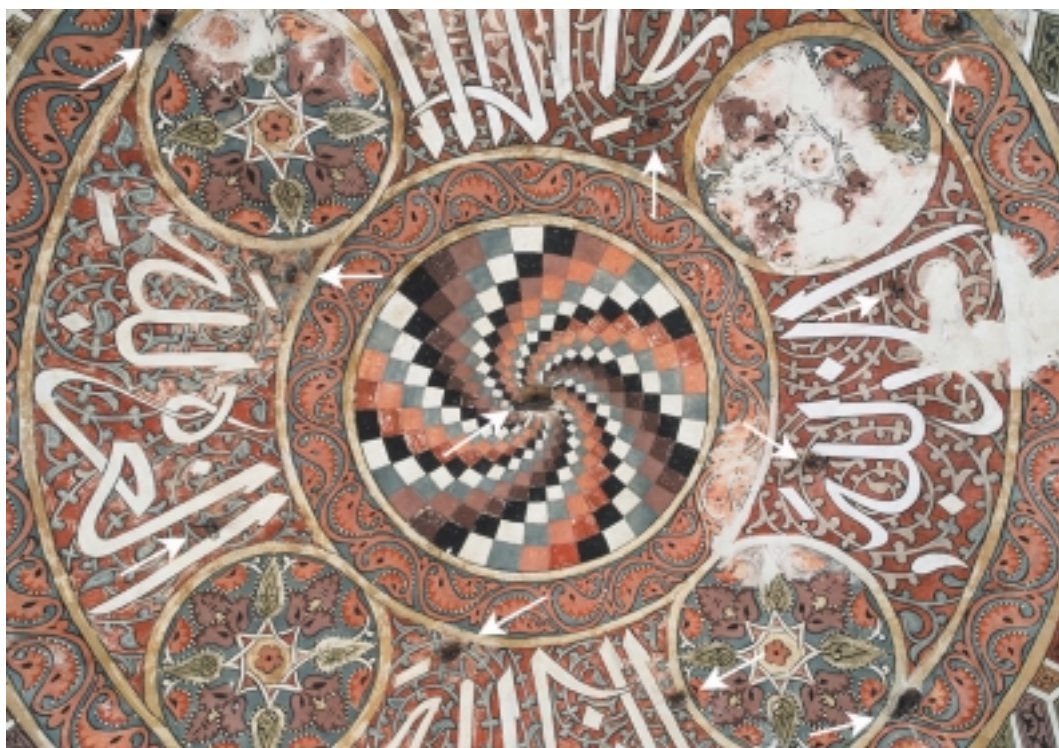
29. Dome 1. Detail showing 11 small wooden beams in situ.

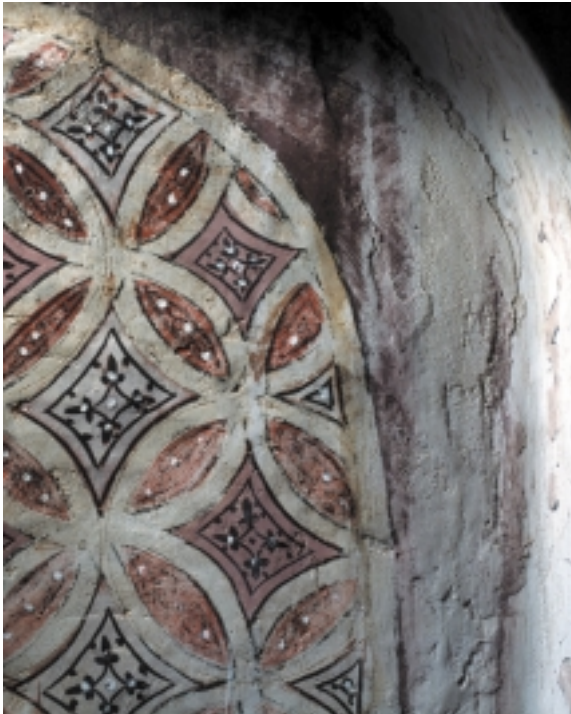
32. Dome 2. The blind niches show an overlapping of the intonaco which seems to be just a hasty fill, albeit subsequently painted

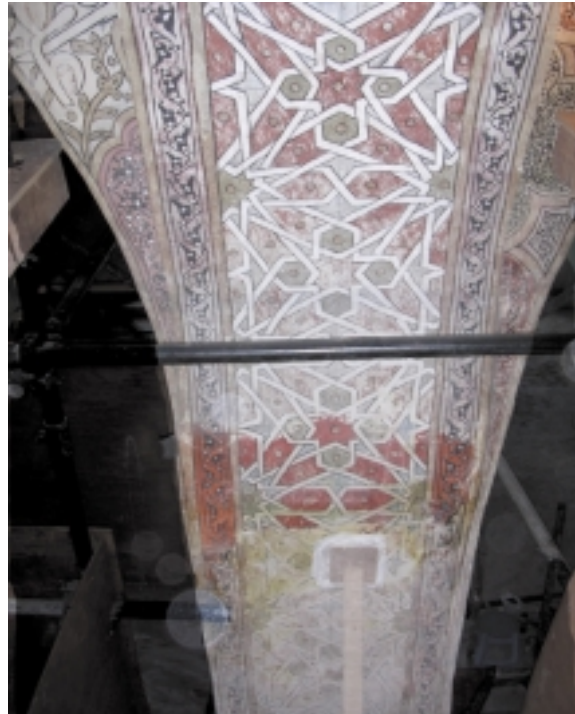
33. The underarch between domes 1 and 2 seems to show an area inaccessible when the original scaffolding covered it.

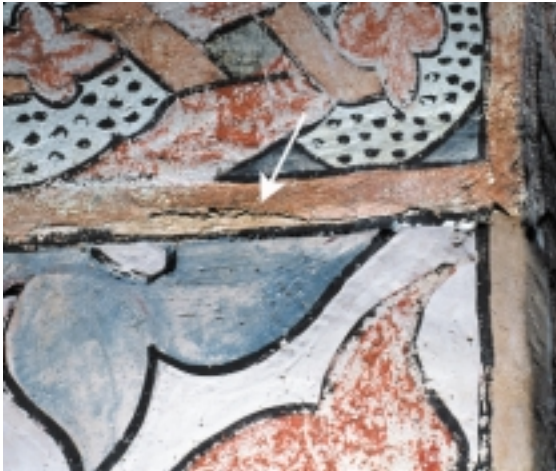
47. In dome 2 where the plaster had fallen we noted paint on the plaster surface partially covered by plaster from the surface below this level.

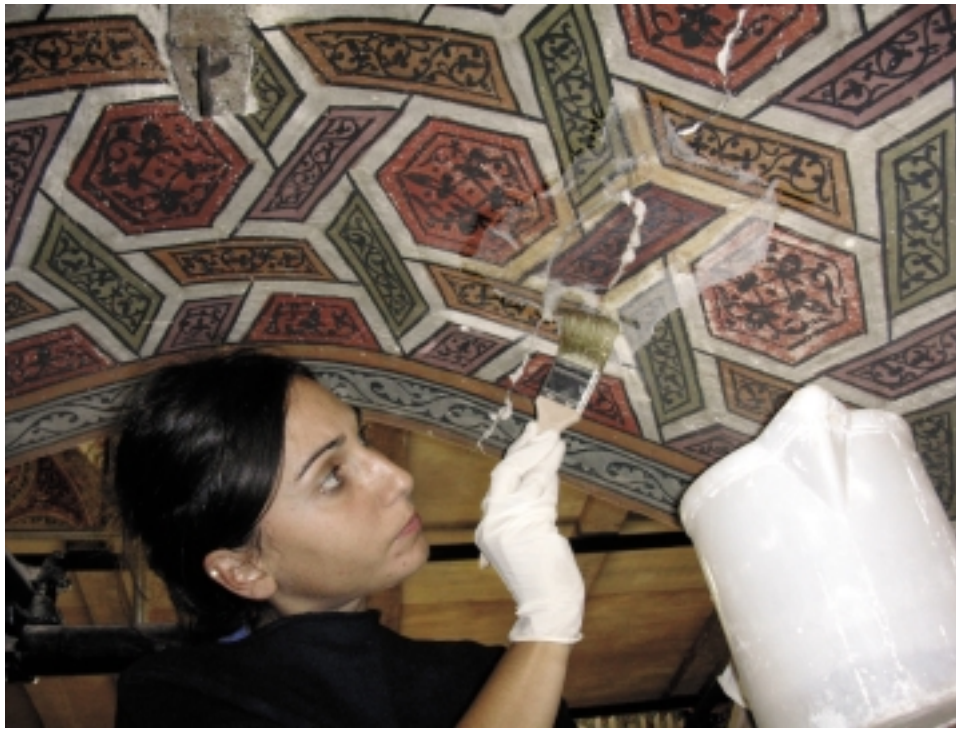
50 Pre-consolidation of the precarious fragments with application of cotton gauze.

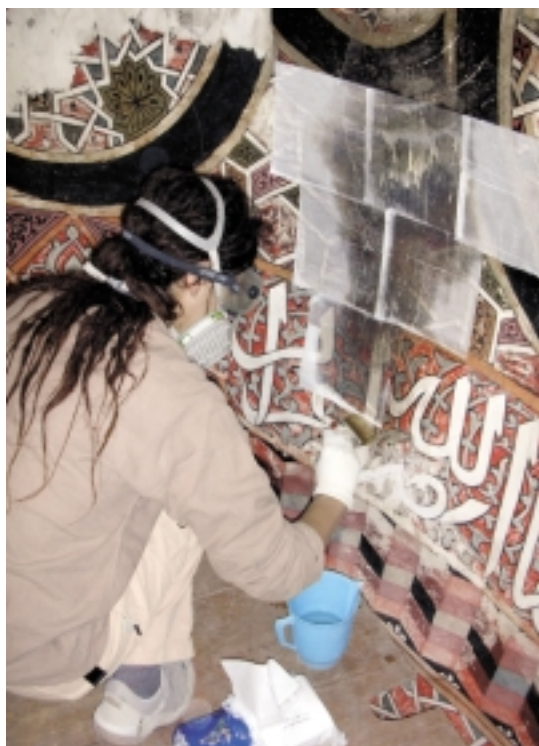
54 Chemical cleaning of the deposits of lampblack.

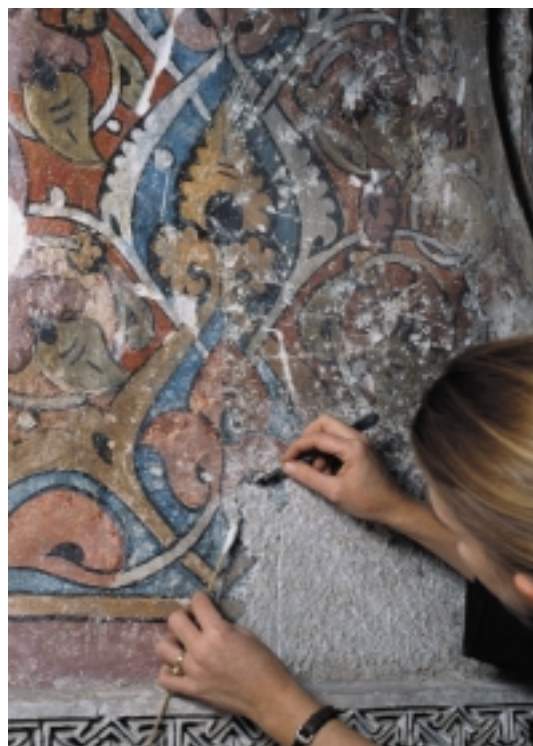
55 Removal of the whitewash by using a scalpel.

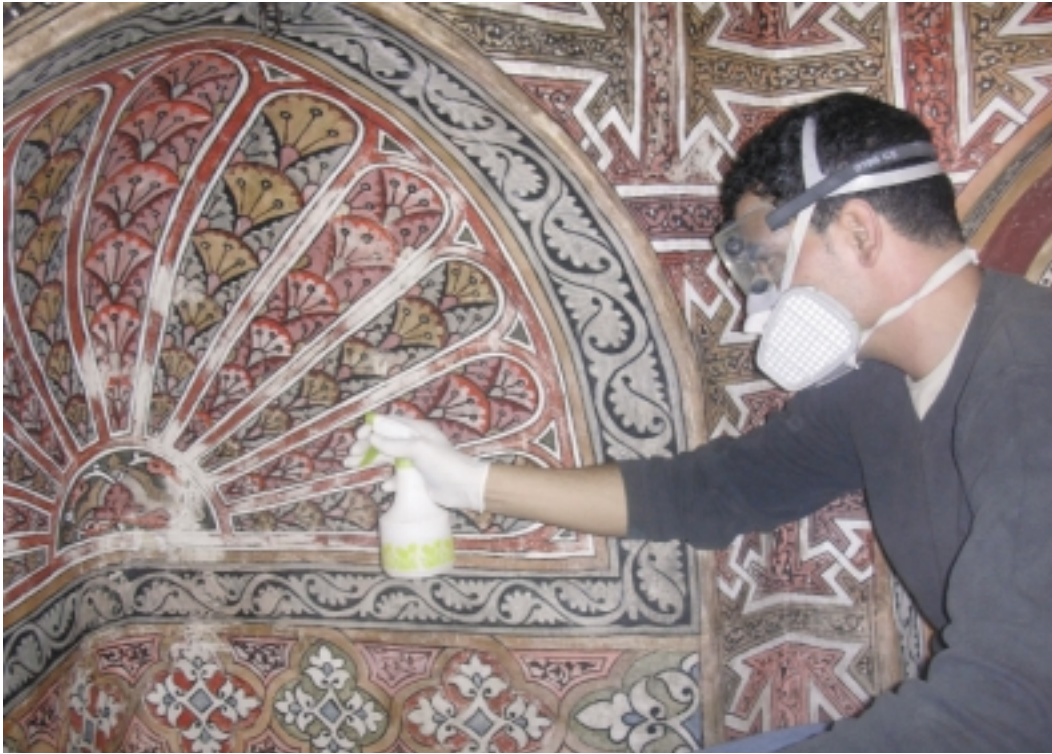
56 Consolidation of the pulverized colour with vaporized acrylic resin.

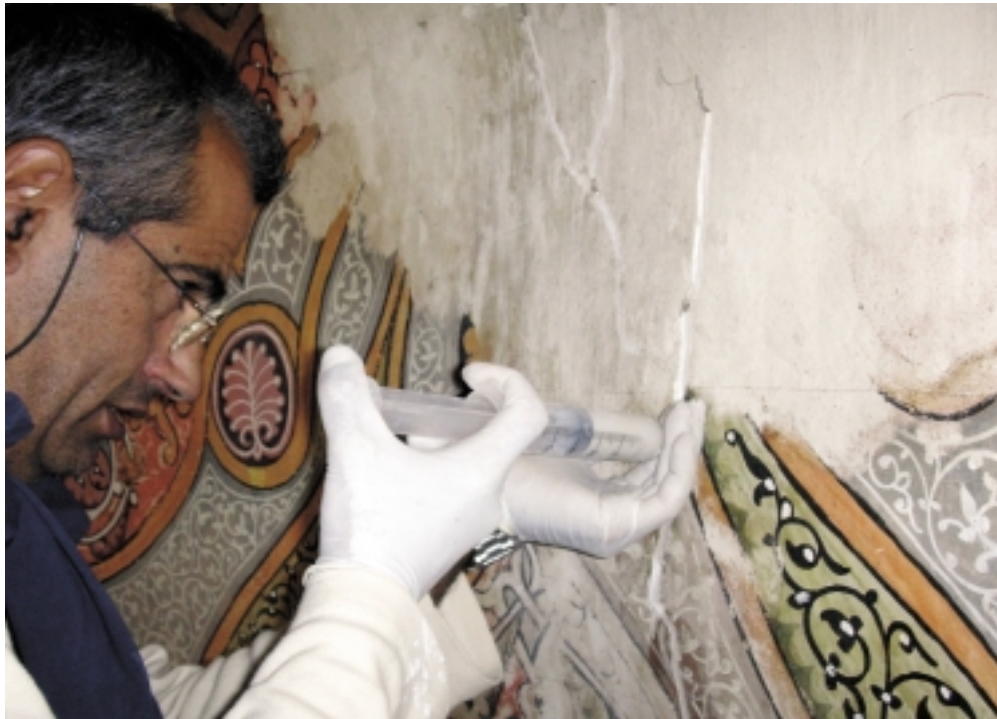
57 Consolidation of the detached plaster with injections of hydraulic consolidant.

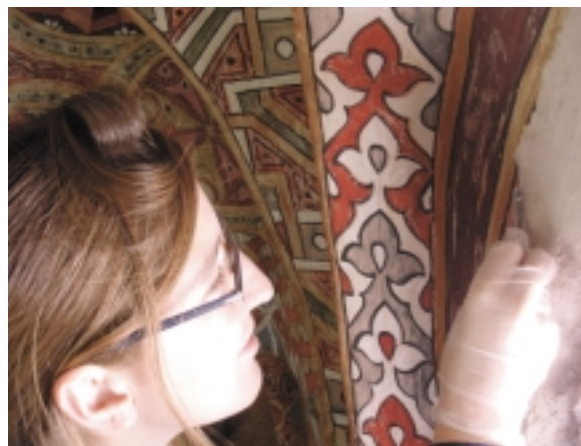
59. Filling of the fractures with gypsum based mortar.

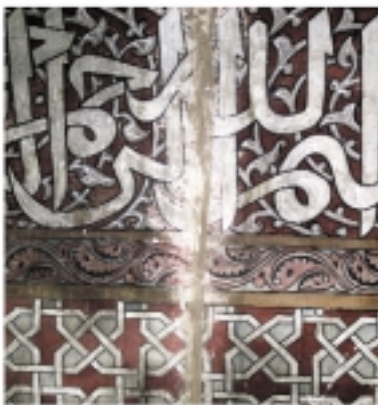
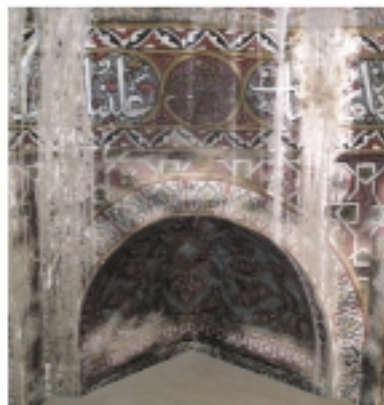
LOSSES IN THE COLOR DUE TO WATER INFILTRATION AND DEPOSITS OF MUD

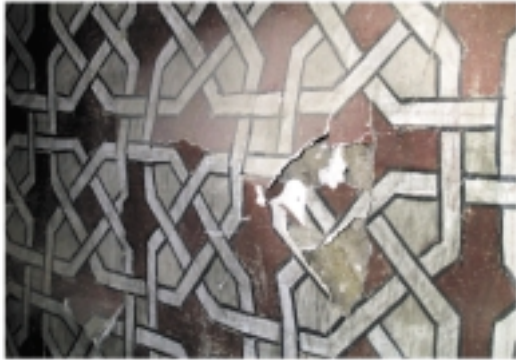
DETACHMENT OF INTONACO

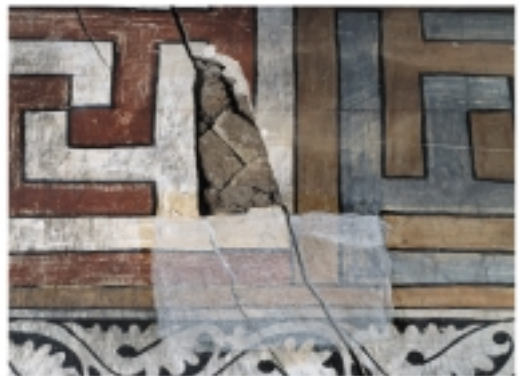
LOSSES IN THE PLASTER AND CRACKS
