# The Legacy of Nora, Sardinia: A Project for the Conservation, Restoration, and Maintenance of Mosaics

Chiara Zizola

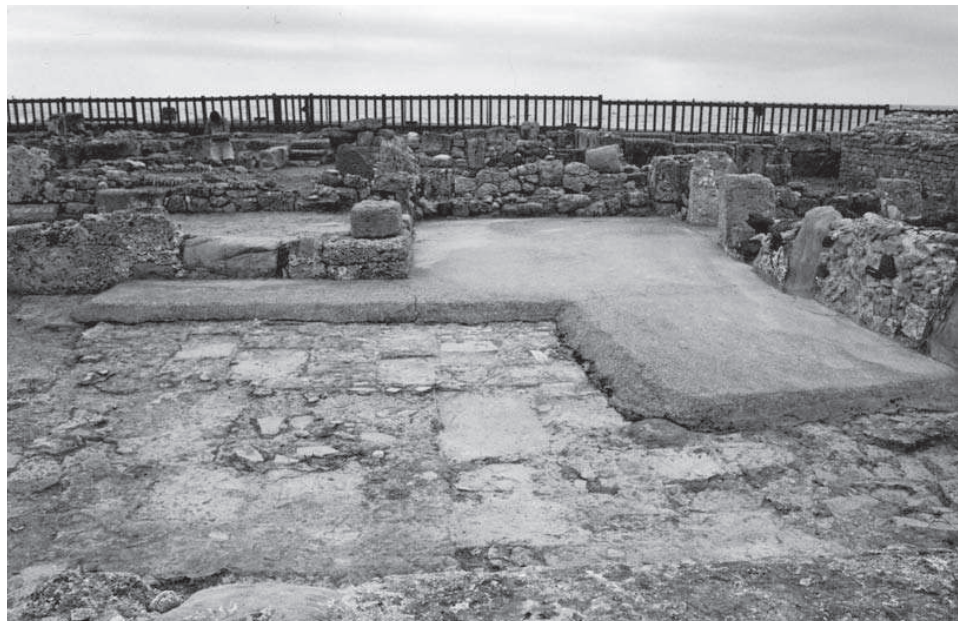
**FIGURE 2** The protective contact covering of lime-cement mortar completely isolates the surfaces from contact with the environment. Courtesy Centro di Conservazione Archeologica-Rome (CCA).

After the excavations in the 1960s an initial major restoration campaign was started in order to prepare the site for public display. Following the popular approach of the time, most of the pavements were detached, mounted on reinforced concrete panels, and relaid in situ, again on cement. By the end of the 1970s, some twenty years after treatment, the restored surfaces presented such serious deterioration that the Superintendency, in the person of Tronchetti, sought various solutions to protect the mosaics. The practice of detachment was abandoned, and newly excavated mosaics were left in situ. The treatments varied according to the seriousness of the condition of the surfaces, as did the decision as to whether or not to leave them on view. Eight pavements still on their original bedding layers and one restored pavement on reinforced concrete were given protective contact covering as follows: a layer of about 5 centimeters of river sand (or quarry sand, without salts), a layer of polyethylene, and a layer of lime-cement mortar of an average thickness of 5 centimeters. This completely isolated the surfaces from exposure to the

environment (fig. 2). Treatment of the remaining, unrestored pavements was limited to reinforcing the edges and filling the lacunae with lime-cement mortar.

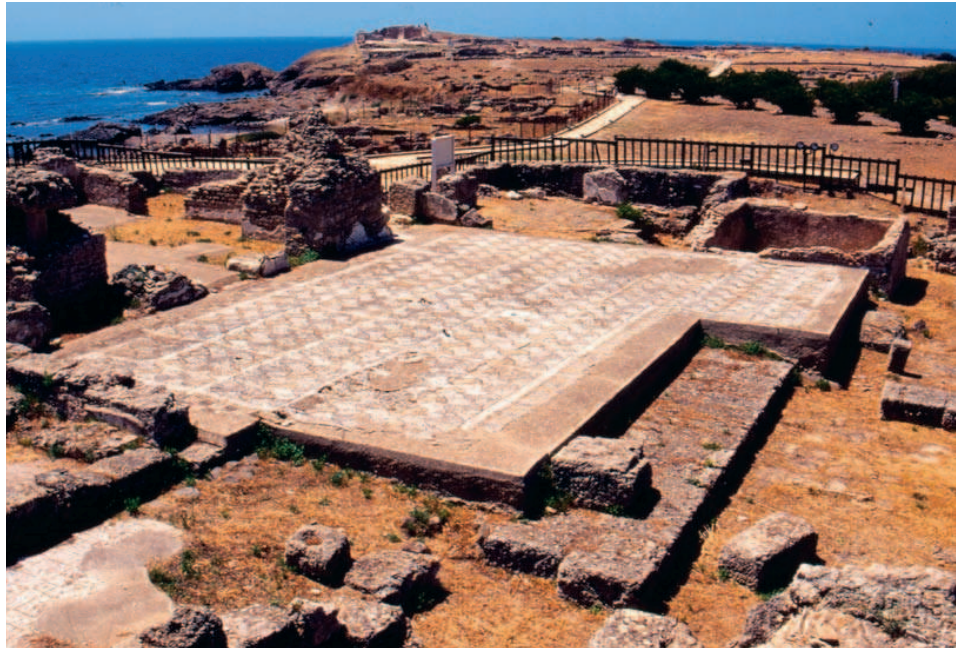
**FIGURE 4** Central baths, *frigidarium*. The pavement is on reinforced concrete with metal rods and suffers from such serious deterioration that the survival of the original material is at great risk. Courtesy Centro di Conservazione Archeologica–Rome (CCA).

concrete with metal rods (fig. 4). For some years now mosaic specialists have known the reasons for this situation: oxidation and consequent expansion of the iron, the excessive hardness and low porosity of cement, and solubilization and crystallization of soluble salts—all these factors take their toll on the ancient materials.

(2) *Pavements detached and reapplied on reinforced concrete in the 1960s*: The majority of these pavements suffer from such serious deterioration that the survival of the original materials is greatly at risk. Because of the total instability of the restoration materials on which the mosaics are bedded, entire portions of *tessellatum* are literally disappearing. On this type of pavement one generally finds explosions beneath the tesserae, with resulting detachment and raising of the *tessellatum*, cracks, subsidence, and progressive and exponential increase in lacunae, along with growth of roots under the tesserae.
